**IMPACT RESISTANCE OF FIBER COMPOSITE
BLADES USED IN AIRCRAFT TURBINE ENGINES**

by
L. A. Friedrich
J. L. Preston, Jr.

**PRATT & WHITNEY AIRCRAFT
DIVISION OF UNITED AIRCRAFT CORPORATION**

Prepared for
NATIONAL AERONAUTICS AND SPACE ADMINISTRATION

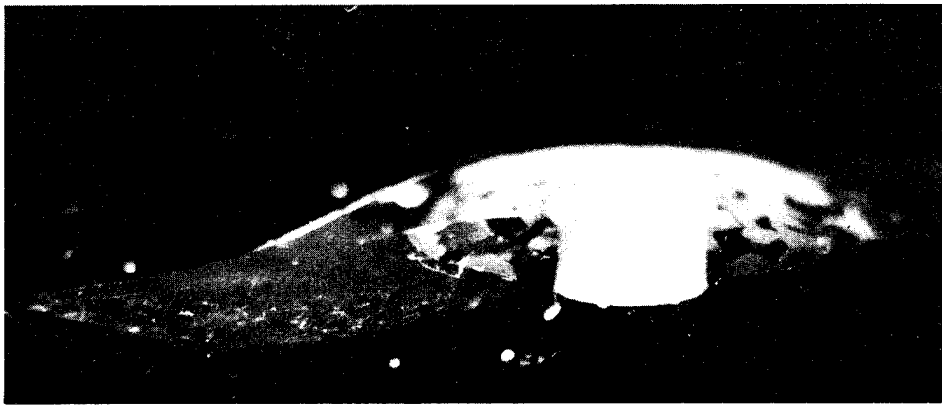
Figure 8 High Speed Strobe Photographs Showing Approach and Impact of a 2.54 cm Diameter Gelatin Ball

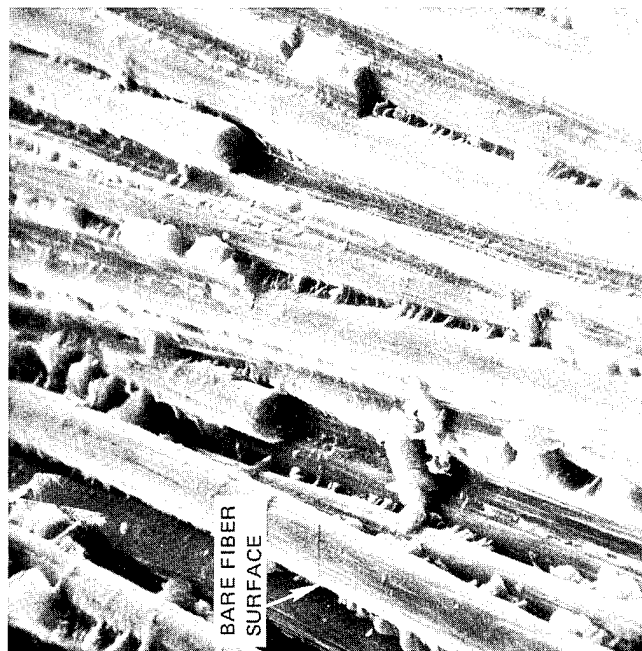
Figure 20 Scanning Electron Microscope Photographs of Typical Interlaminar Fracture Surfaces From Impacted Modmor II/PR-286 Specimens

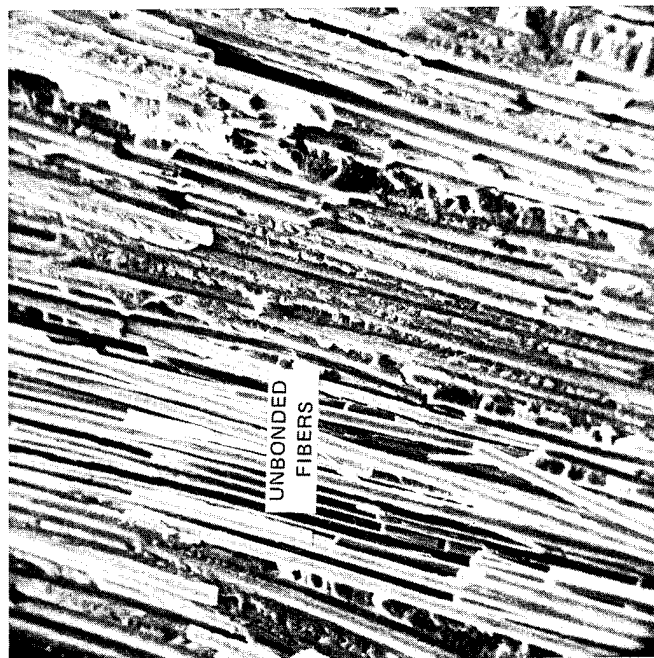
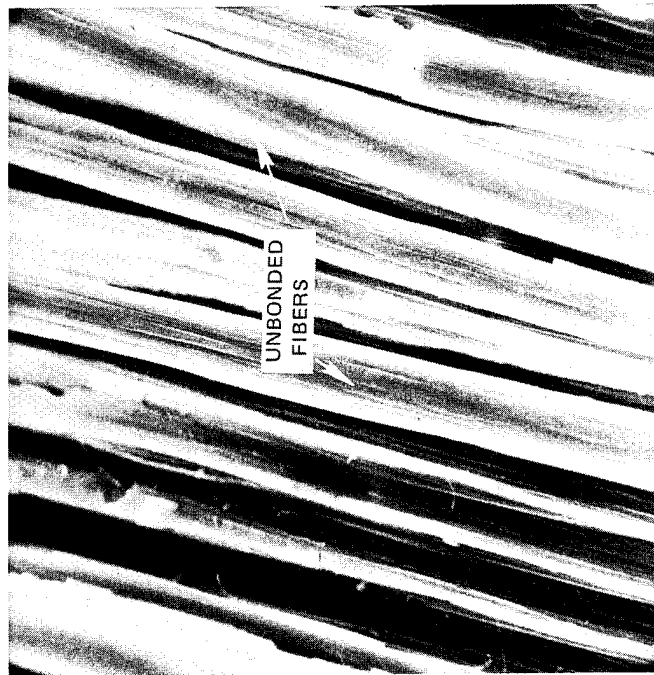
Figure 21 Scanning Electron Microscope Photographs of a Modmor II/PR-286 Transverse Tensile Specimen Fracture. (Note Completely Unbonded Fibers)

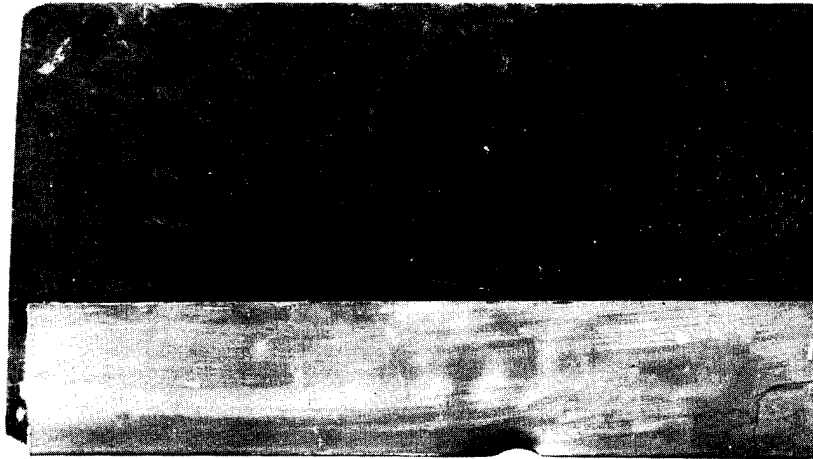
Figure 34 Effect of Leading Edge FOD Shield Against Steel Projectiles at 274 m/sec (900 ft/sec). All Spin Impacts at 15° to the Leading Edge. (Mag: 0.9X)
